**Flood Control Project Maintenance
Levee Inspections**
LMA District Cover Sheet
Spring 2019 Levee Inspection Results

Reclamation District No. 1000 Natomas

Spring 2019 Levee Inspection Results

Waterway			Bank	Unit Miles
Unit No. 01 Sacramento River			Left	18.28
	Spring (March - May)	Summer (June - August)	(September - November) Fall	Winter (December - February)
Unit Maintenance Rating (Fall Only)				
Date of Inspection	4/16/2019 - 4/16/2019			
DWR Inspector	Sterling York			
Accompanied By	Don Caldwell RD1000

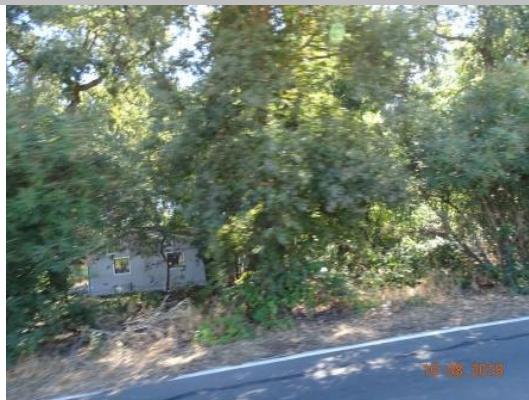
Photo 1 of 1 : SP_2019_RD1000_31_69_20190305_00028.jpg

LM Start	11.66	Rating **	M	Issue No.	69
LM End	11.70	Issue Type +	En	Location *	WS
Category	Earthen Levee			GPS Latitude/Longitude	
				Start	End
Item	Vegetation			38.647392 °	38.647773 °
				-121.581946 °	-121.581423 °
DWR ID	DWR_RD1000_01_s_2012_69				
Comment Code					
V6 : Landscaping					
Inspector Comment					
Landscape vegetation blocks access and visibility, Fall 2018.

View of landscape vegetation that blocks access and visibility, Fall 2018.
